RETROFITTING MANUAL FOR ENGINEERS ON CONSTRUCTION OF DISASTER RESILIENT SHELTER CONSTRUCTIONS

May 2019

Retrofitting Manual for Engineers on Flood and Landslide Resistant Shelter Construction Practices

Author: Anshuman Shukla CEO, TESRA

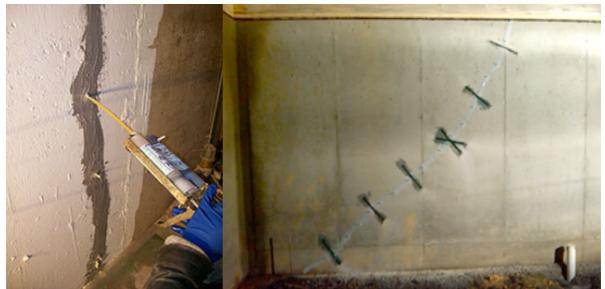
Figure 13:Image showing repair of crack using injection technique (*left*), repair of crack using diagonal bracing (*right*). (*credit: www.a1crackrepair.com*)

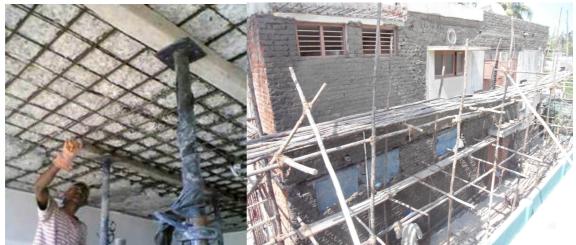
Figure 14:Image showing re-plastering and restoration of slab (*left*), Restoration process of front facade of building(*right*). (*credit: RMS civil repair works*)

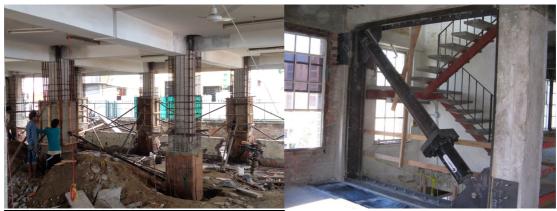
Figure 15: Images showing example of Retrofitting of basement (credit: urbansolutionsbd.blogspot.com)

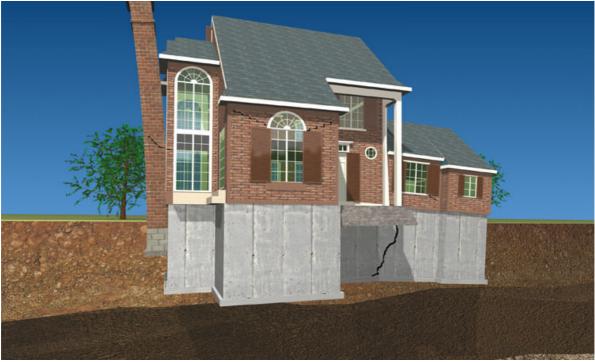
Figure 17: Image showing example of foundation sinking (credit: www.clarkebasementsystems.com)

On the basis of damage assessment, the result should be quantified, and Different retrofitting techniques should be adopted to rehabilitate the structure. In case of sinking is very important to identify the cause of sinking, if the sinking is due to water penetration, then before retrofitting proper plinth protection is needed to be installed, otherwise different retrofitting measures like repair of structural cracks using wire mesh, extension of foundation, grouting of concrete under the foundation etc. should be adopted. For the detailed installation process of retrofitting measures refer section 10.1.

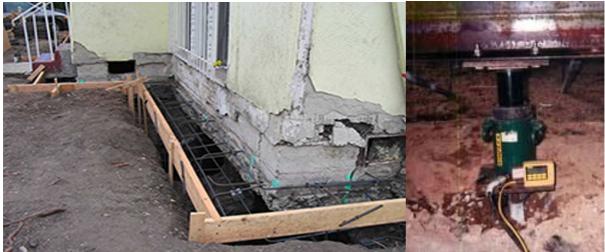
Figure 18: Image showing example of Retrofitting foundation using Jacks and extra reinforcement (credit: <u>www.renotahoefoundationrepair.com</u>)

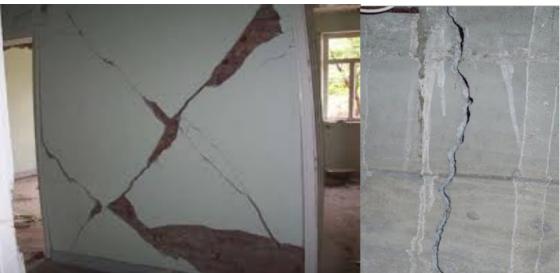
Figure 20:Image showing example of structural cracks in wall due to flood (credit: www.iitk.ac.in)

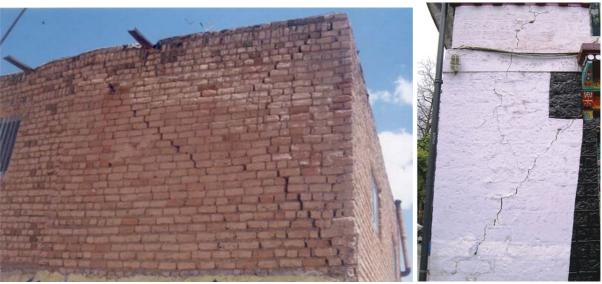
Figure 21: Image showing example of structural cracks in wall due to landslides (credit: ascelibrary.org)

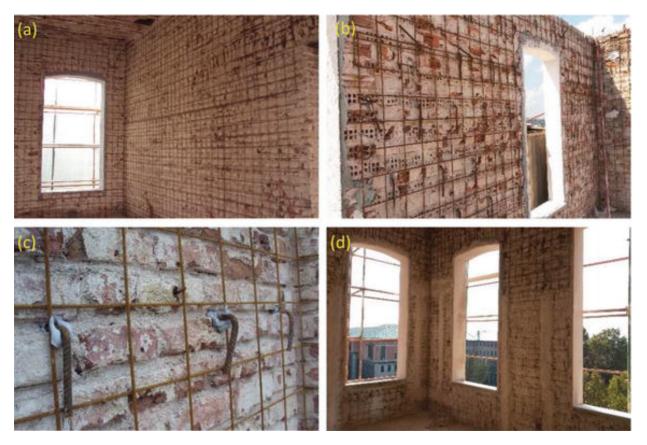
Figure 25: Retrofitting procedure of masonry building using iron bars (credit: www.intechopen.com)

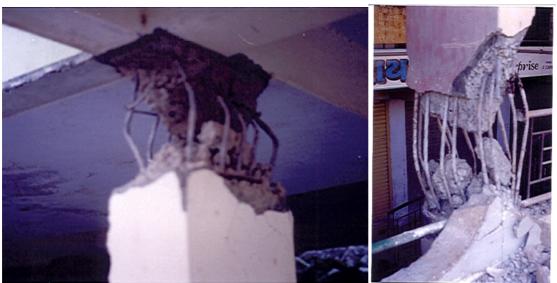
Figure 26: image showing damage in columns due to dynamic loading (credit: TESRA ppt)

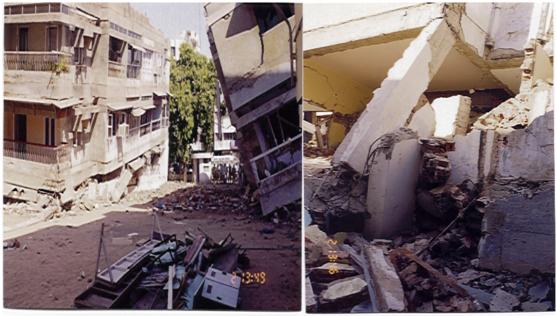
Figure 27: Collapse pattern due to soft story failure due to column failure (*credit: TESRA ppt*) **General retrofitting technique:** On the basis of damage assessment the result should be quantified, and Different retrofitting techniques should be adopted to rehabilitate the structure. if column is failing due to lack of concrete, then jacketing of column should be done. There are other several techniques are available for the retrofitting of columns as follows:

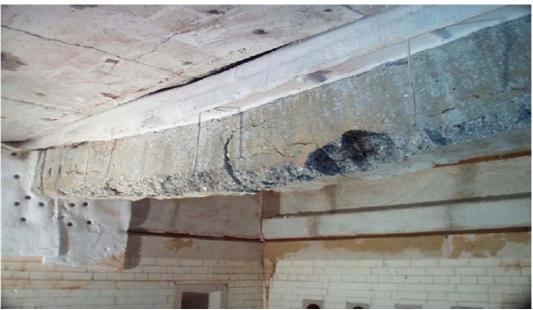
Figure 30: damage due to sagging (credit: daily civil)

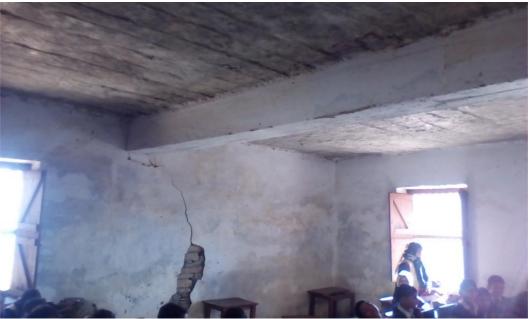
Figure 31: damage in wall and slab due to sagging (credit: daily civil)

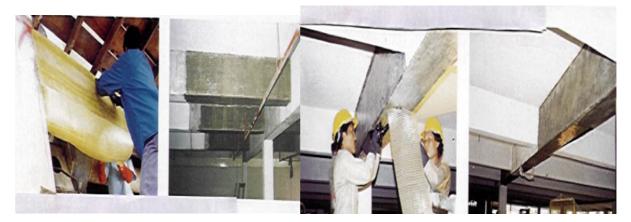
Figure 32: Jacketing of Beam using FRP (credit: TESRA ppt)

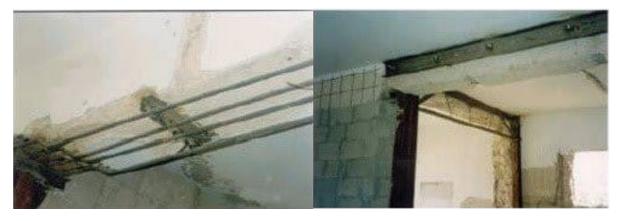
Figure 35: jacketing by bars in beam (left) and Strengthening by steel plate (right) (credit: researchgate)

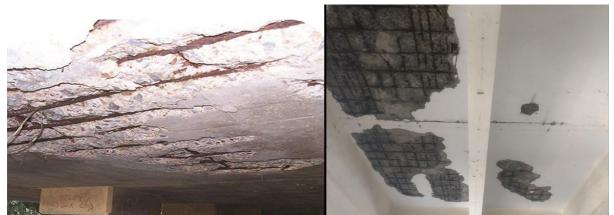
Figure 36: de-lamination and rusting in slab (left) and de-lamination of plaster in slab (right) (credit: researchgate)

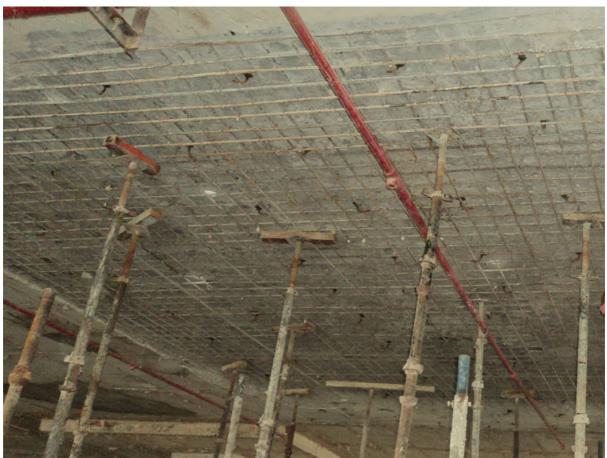
Figure 37: surfaces preparation for shot-crete (credit: researchgate)

- 1. Shot-crete the slab after removal of plaster.
- 2. In case of sagging, installation of extra beam support.
- 3. Re-plastering of exposed reinforcement.
- 4. Re-barring of slab using shear anchor.

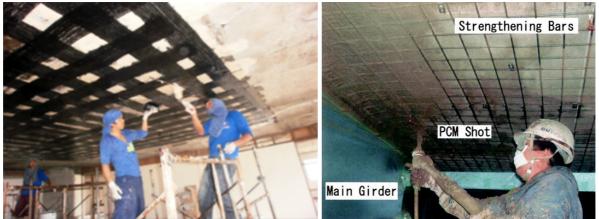
Figure 38: retrofitting using FRP (left) and shot-crete in slab (right) (credit: researchgate)

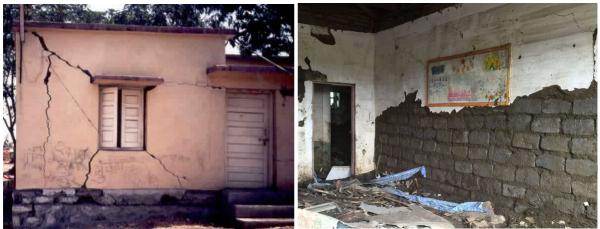
Figure 39: structural damage around opening (left) and damage due to flood (credit: http://db.world-housing.net)

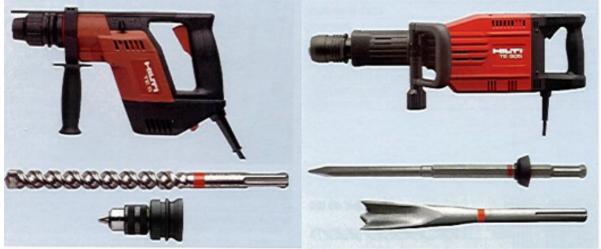
Figure 47: Ferro- Rotatory hammer drill (credit: TESRA ppt)

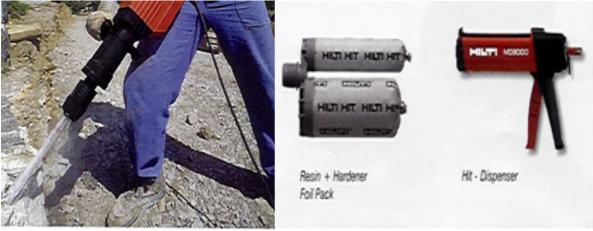
Figure 48: Re-bar fastening machine (credit: TESRA ppt)

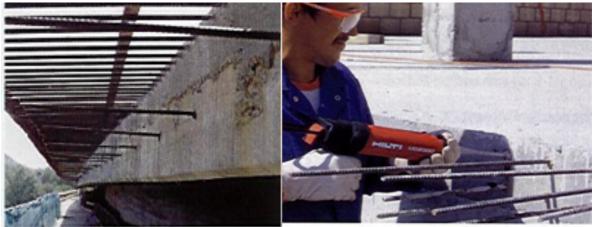
Figure 49: Re-bar fastening machine application (credit: TESRA ppt)

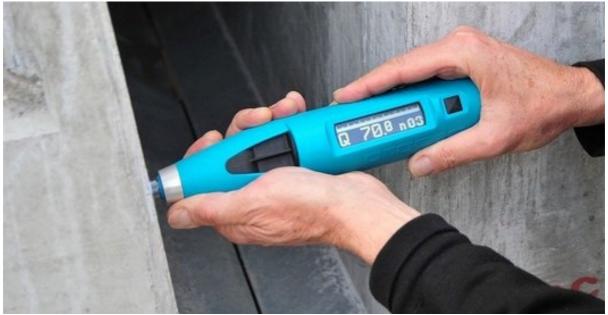
Figure 51: Re-bound hammer testing of concrete element (credit: gharpedia.com)

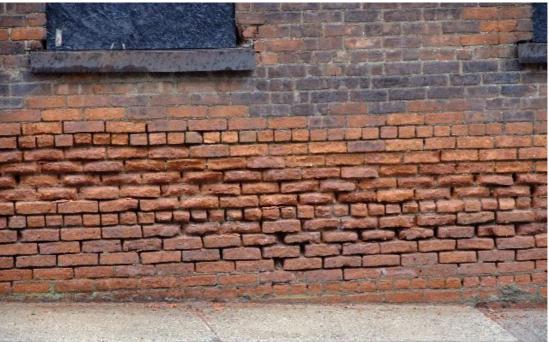
Figure 55: Image showing erosion of mortar due to flood water (credit: inspectapedia.com)

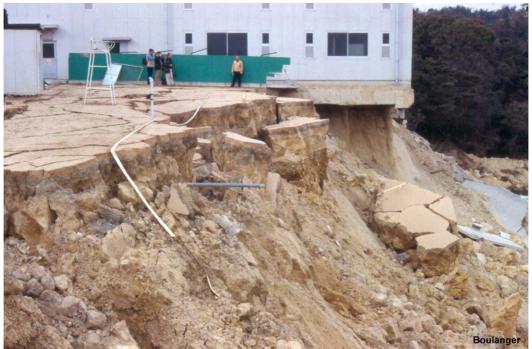
Figure 59: Base soil under foundation eroded due to landslide (credit: http://www.stuff.co.nz)

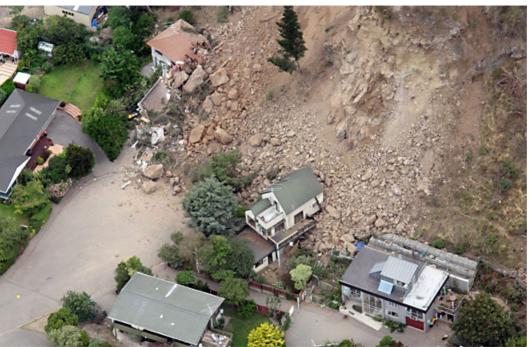
Figure 60: Building partially buried due to landslide (credit: http://www.stuff.co.nz)

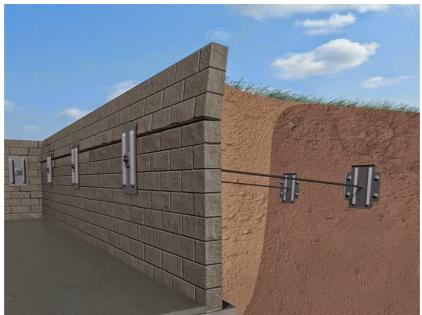
Figure 61: retrofitting using steel plates for basements (credit: TESRA ppt)
