RETROFITTING MANUAL FOR MASONS ON FLOOD AND LANDSLIDE RESISTANT SHELTER CONSTRUCTION PRACTICES

May 2019

Author:
Anshuman Shukla
CEO, TESRA

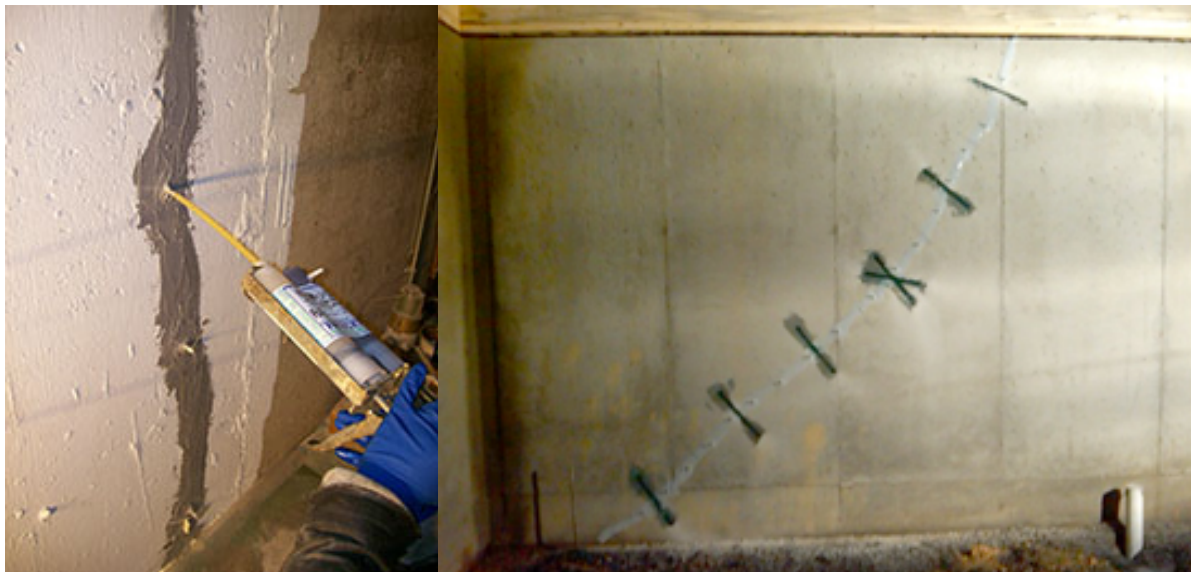
Figure 11: Image showing repair of crack using injection technique (left), repair of crack using diagonal bracing (right). (credit: www.a1crackrepair.com)

1. The repairs are performed on damaged buildings to restore the strength after disaster.
2. The repair services include:
 - a. Reconstruction of non-structural walls, chimneys , boundary walls etc.
 - b. Checking and repairing electrical connections, plumbing , ventilation etc.
 - c. Repairing of cracks

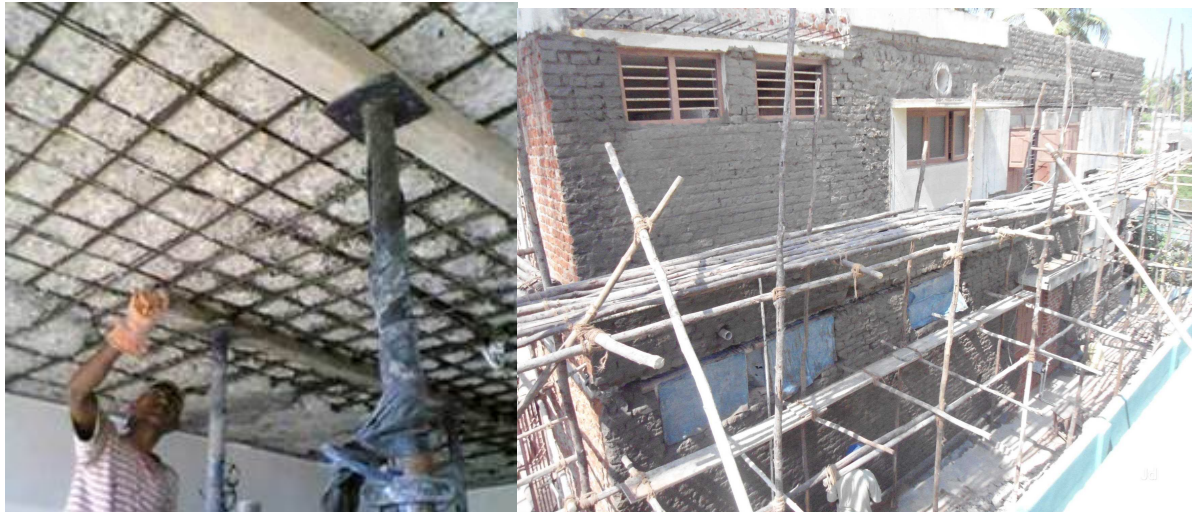
Figure 12: Image showing re-plastering and restoration of slab (left), Restoration process of front facade of building (right). (credit: RMS civil repair works)

1. The restoration is performed to retain the strength of existing building to the original strength.
2. The restoration enables to get at least the original strength of piers, Columns, beams and walls.
3. The following are the actions involved in restoration:
 - a. By grouting
 - b. Strengthening using wire mesh
 - c. Rebuilding the cracked portions using rich non-shrinkable mortar after removal of cracked portion.

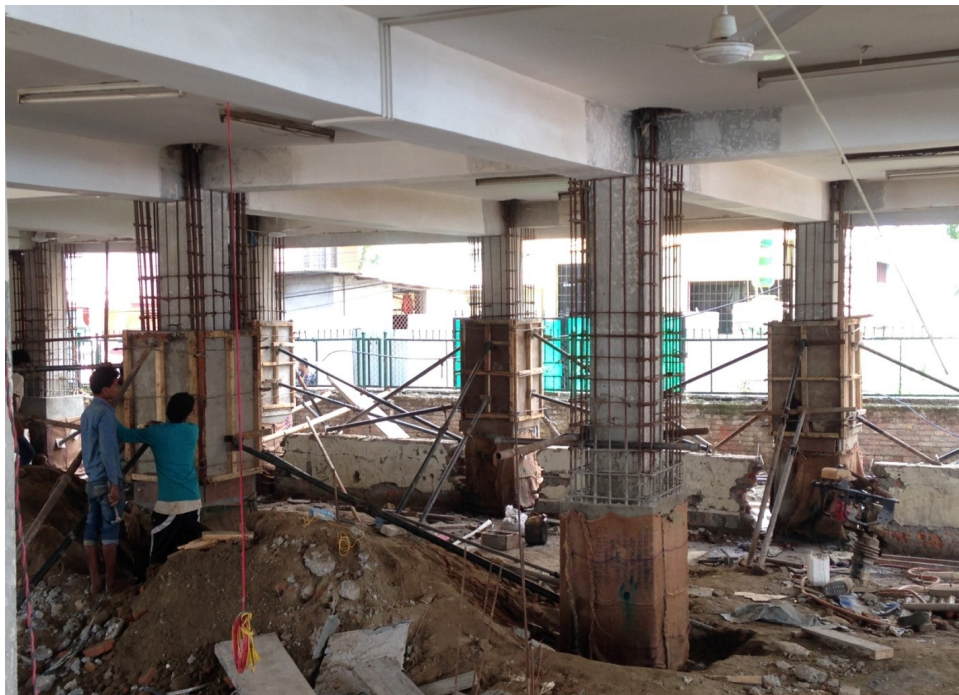
Figure 13: Image showing example of Retrofitting of basement (credit: urbansolutionsbd.blogspot.com)

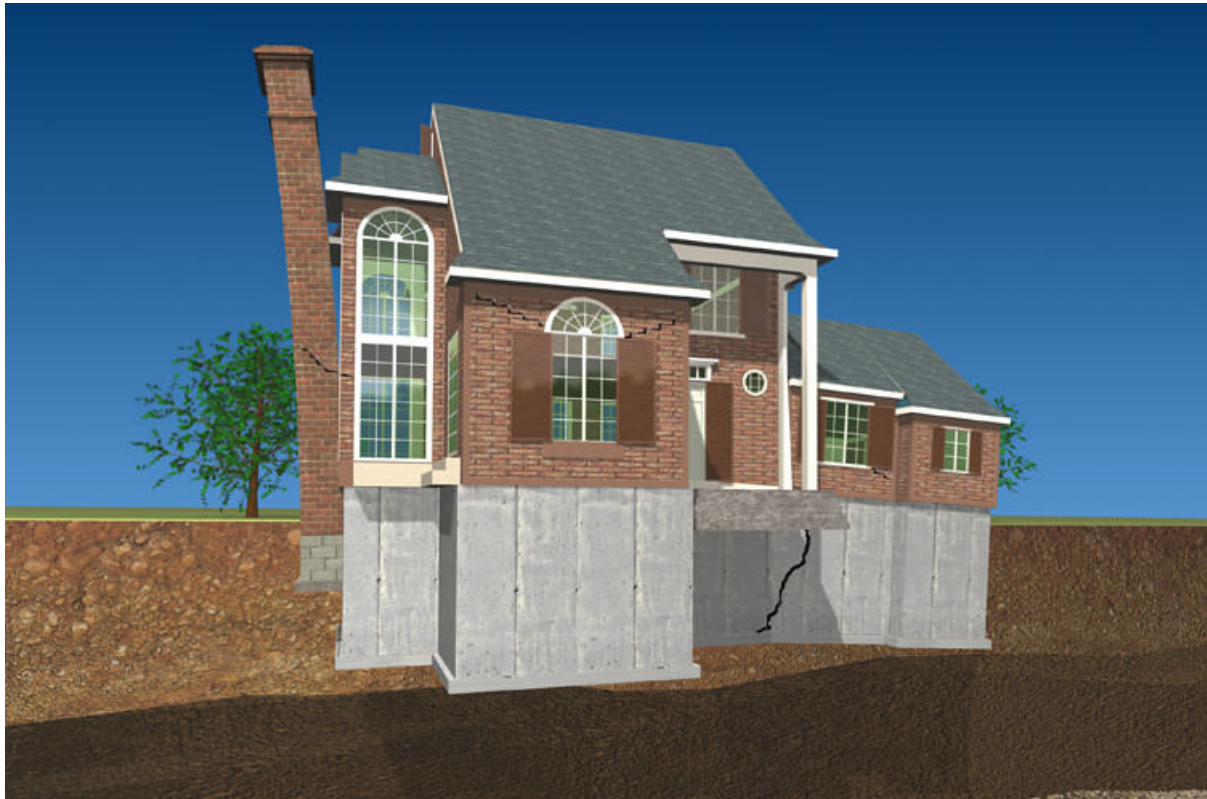
Figure 15: Image showing example of foundation sinking
(credit: www.clarkebasementsystems.com)

Damage assessment: Foundation is the most important part of the structure; it transfers superstructure load to the ground. If the structure exposed to the dynamic loading, there are several types of damage observed in foundation some of the general observations are as follows:

1. Sinking in foundation.
2. Structural crack in foundation.

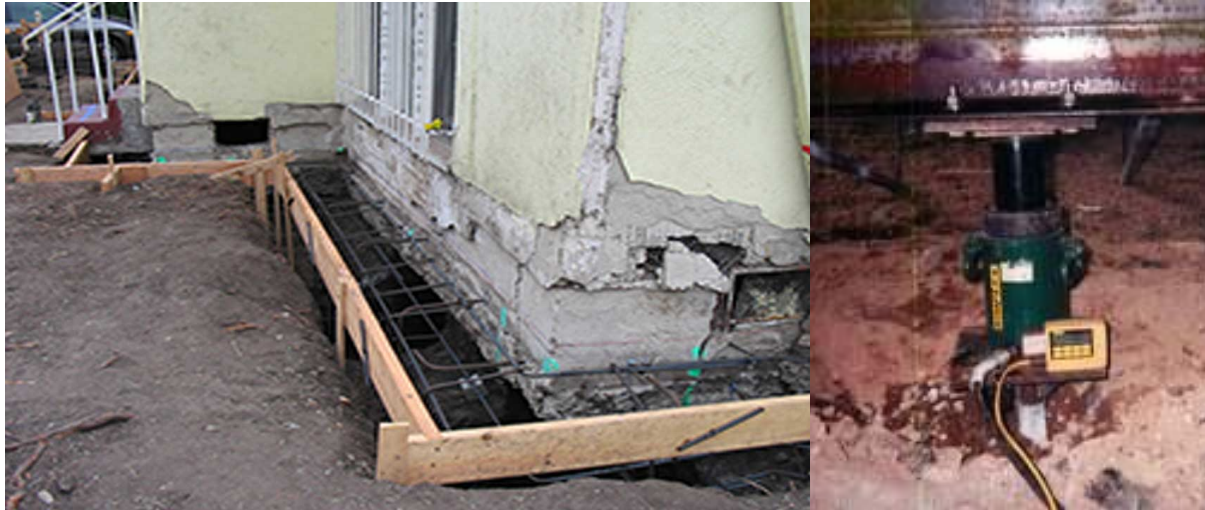
Figure 16: Image showing example of Retrofitting foundation using Jacks and extra reinforcement
(credit: www.renotahoe.foundationrepair.com)

On the basis of damage assessment, the result should be quantified, and Different retrofitting techniques should be adopted to rehabilitate the structure. In case of sinking is very important to identify the cause of sinking, if the sinking is due to water penetration, then before retrofitting proper plinth protection is needed to be installed, otherwise different retrofitting measures like repair of structural cracks using wire mesh, extension of foundation, grouting of concrete under the foundation etc. should be adopted. For the detailed installation process of retrofitting measures refer section 10.1.

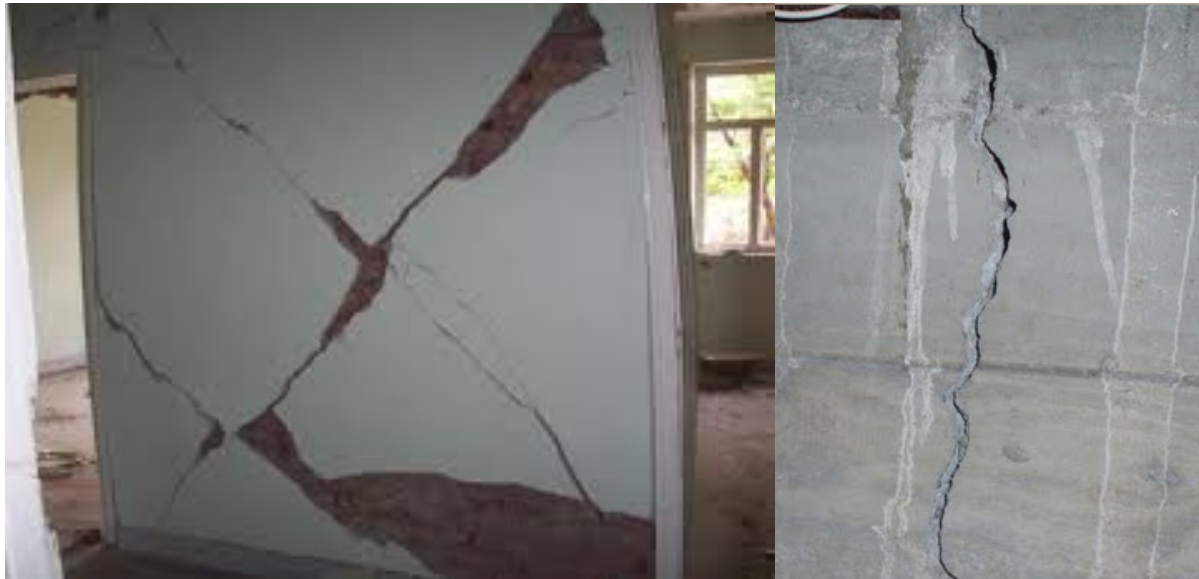
Figure 18: Image showing example of structural cracks in wall due to flood
(credit: www.iitk.ac.in)

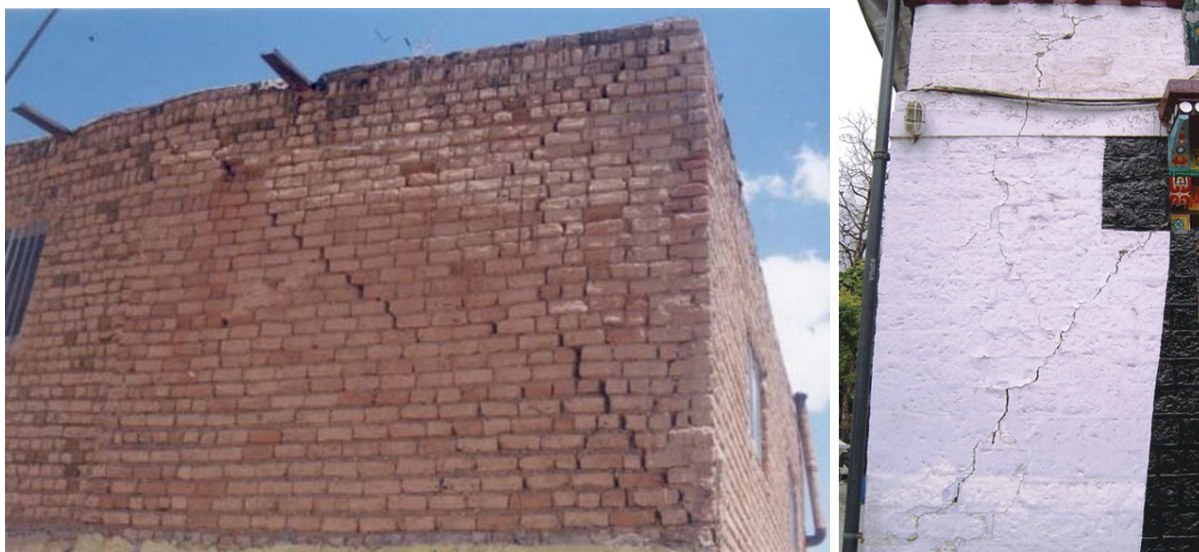
Figure 19: Image showing example of structural cracks in wall due to landslides
(credit: ascelibrary.org)

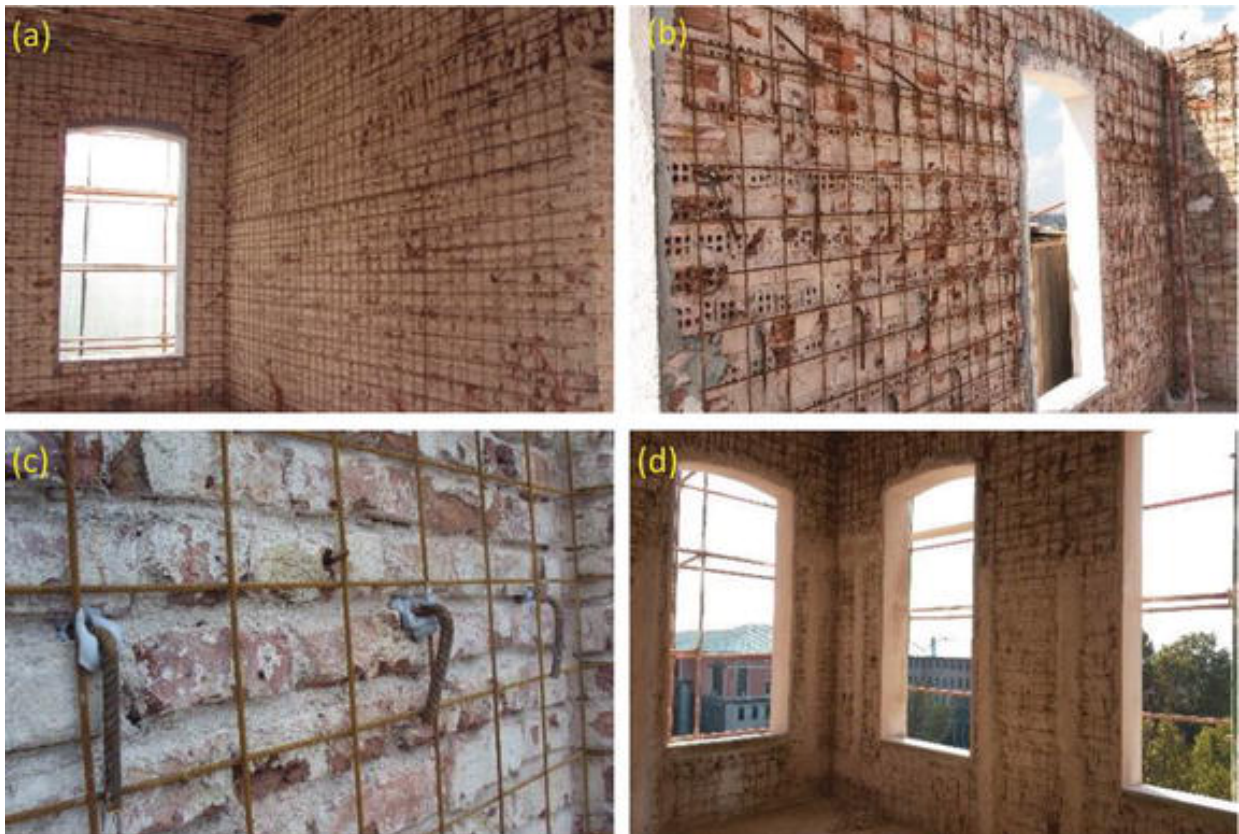
Figure 23: Retrofitting procedure of masonry building using iron bars (credit: www.intechopen.com)

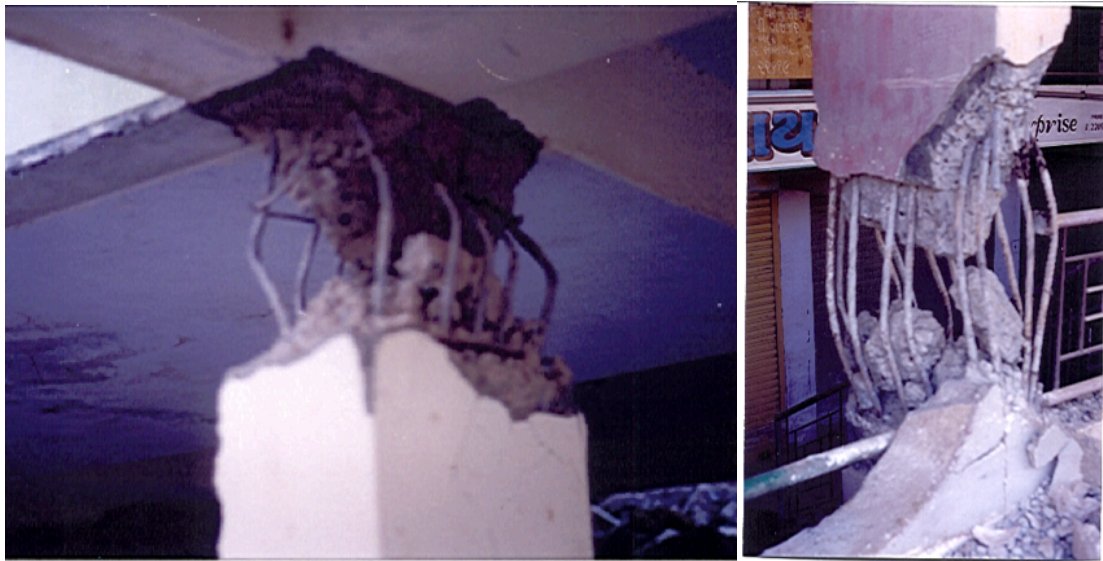
Figure 24: image showing damage in columns due to dynamic loading
(credit: TESRA ppt)

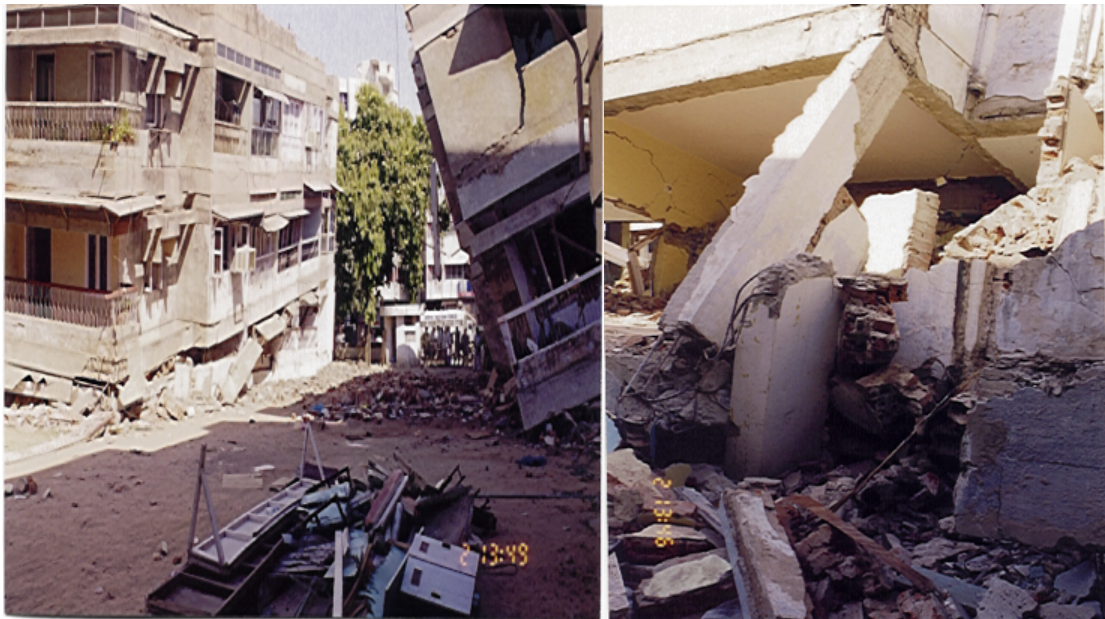
Figure 25: Collapse pattern due to soft story failure due to column failure (credit: TESRA ppt)

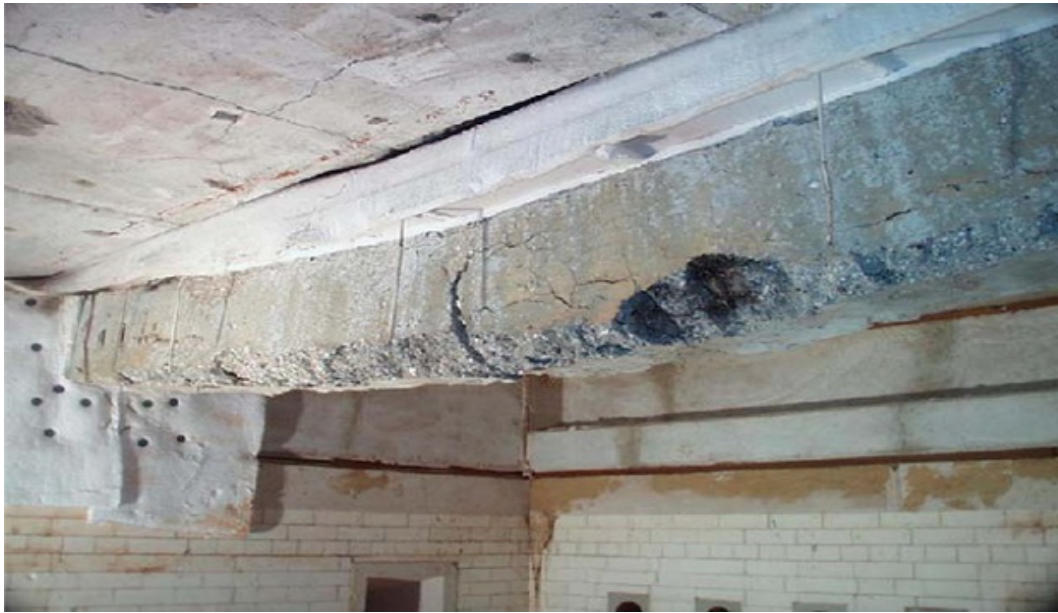
Figure 28: damage due to sagging (credit: daily civil)

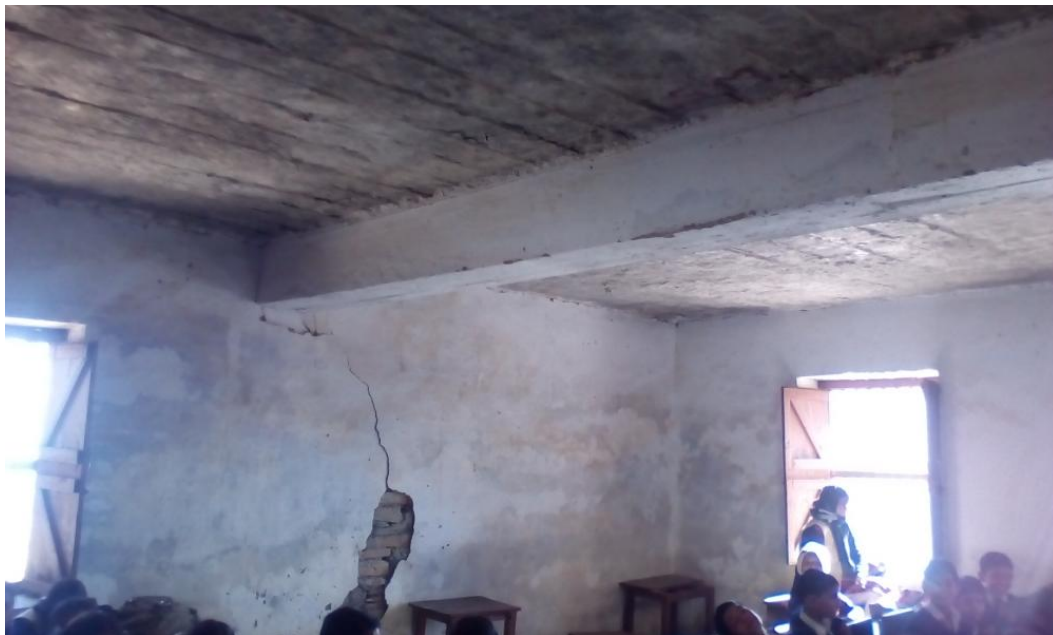
Figure 29: damage in wall and slab due to sagging (credit: daily civil)

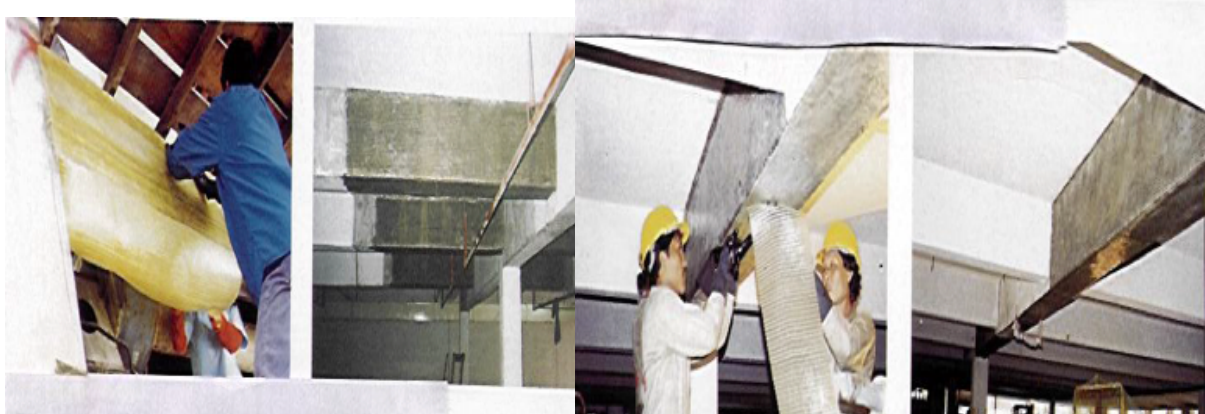
Figure 30: Jacketing of Beam using FRP (credit: TESRA ppt)

1. Jacketing of beam using RCC
2. Jacketing of beam using FRP
3. Retrofitting of beam to beam connection using Steel plates
4. Introduction of bracings to support the beam

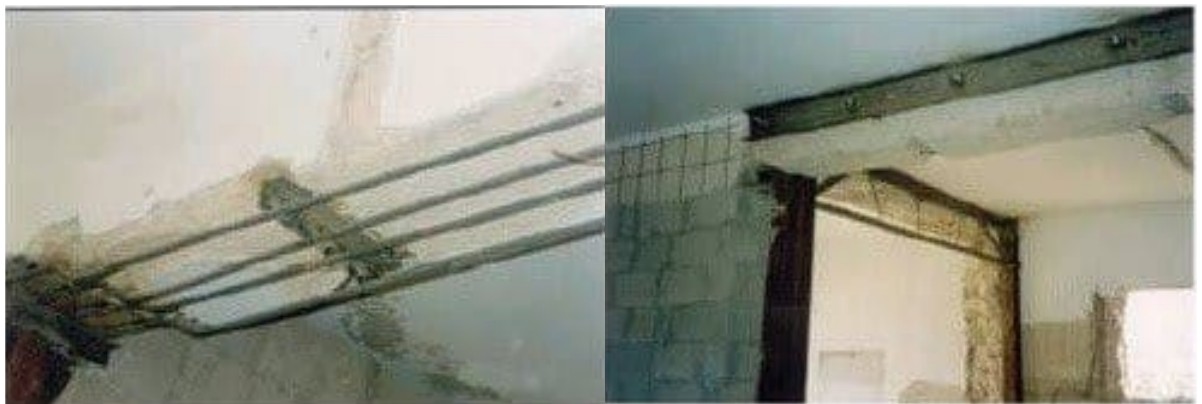
Figure 33: jacketing by bars in beam (left) and Strengthening by steel plate (right) (credit: researchgate)

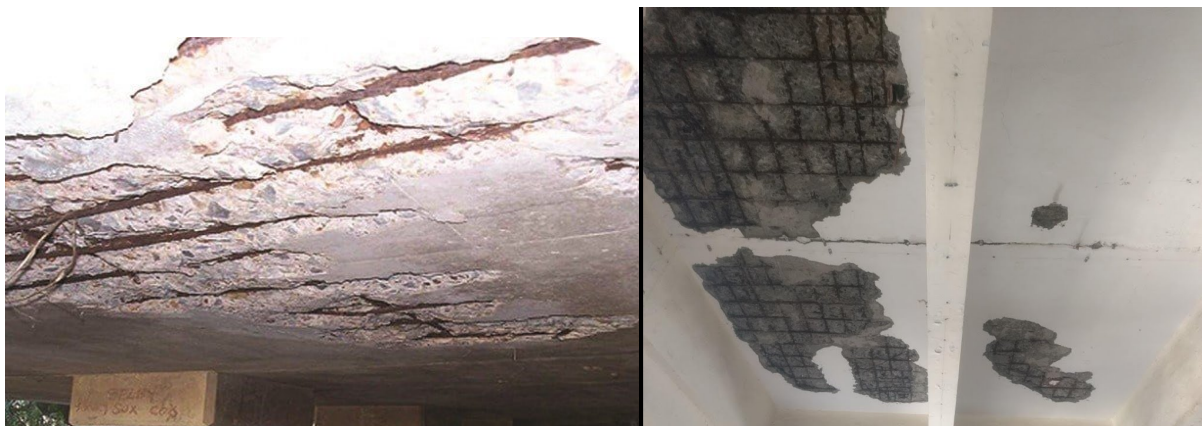
Figure 34: de-lamination and rusting in slab (left) and de-lamination of plaster in slab (right) (credit: researchgate)

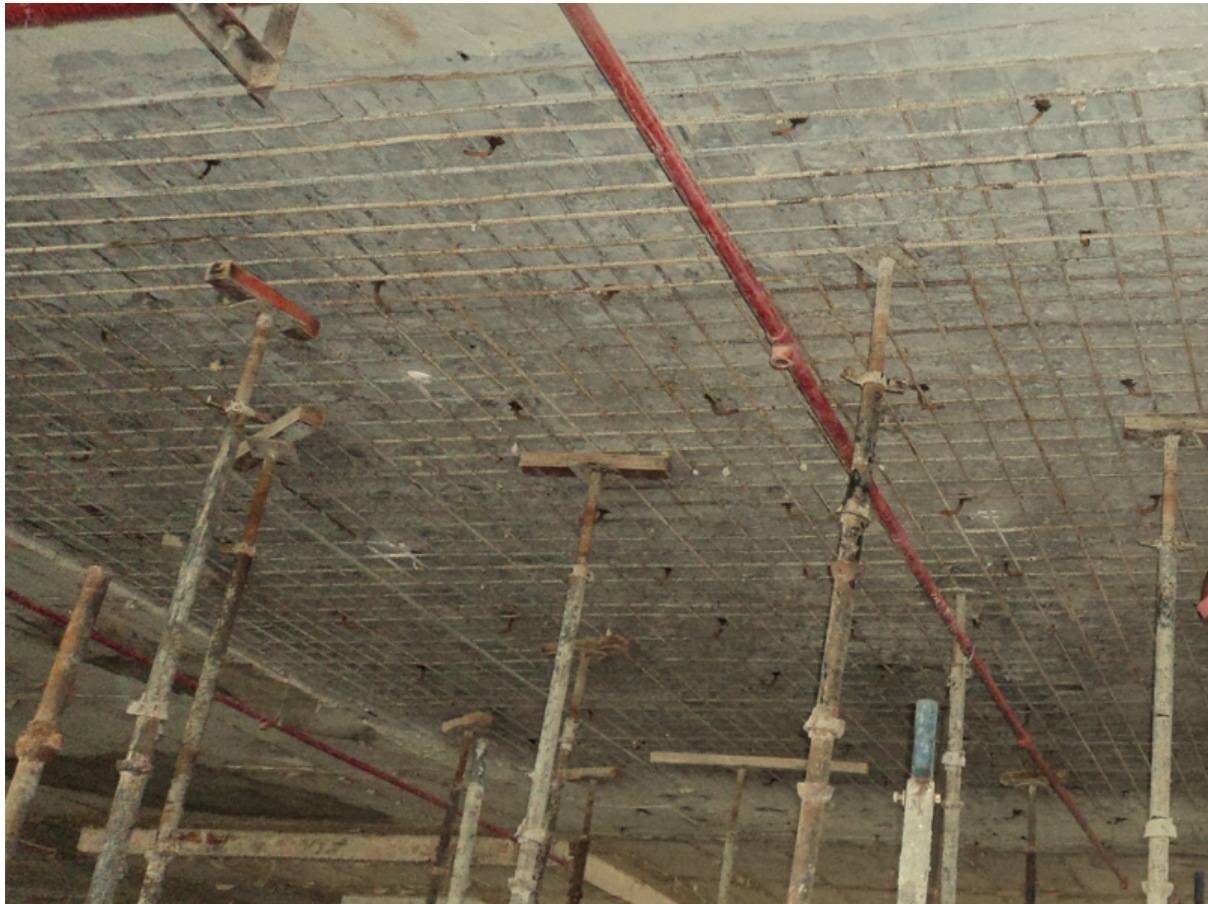
Figure 35: surfaces preparation for shot-crete (credit: researchgate)

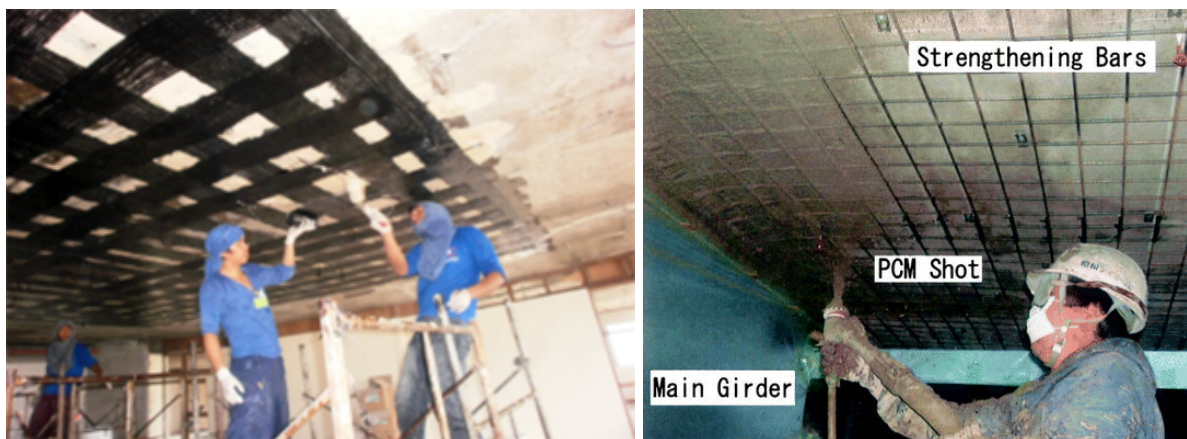
Figure 36: retrofitting using FRP (left) and shot-crete in slab (right) (credit: researchgate)

1. Shot-crete the slab after removal of plaster.
2. In case of sagging, installation of extra beam support.
3. Re-plastering of exposed reinforcement.
4. Re-barring of slab using shear anchor.

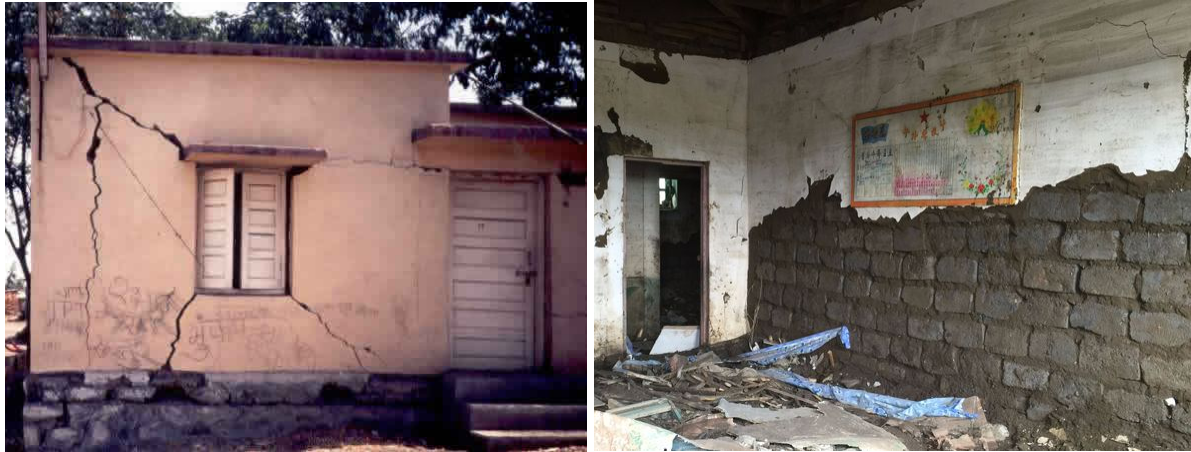
Figure 37: structural damage around opening (left) and damage due to flood (credit: <http://db.world-housing.net>)

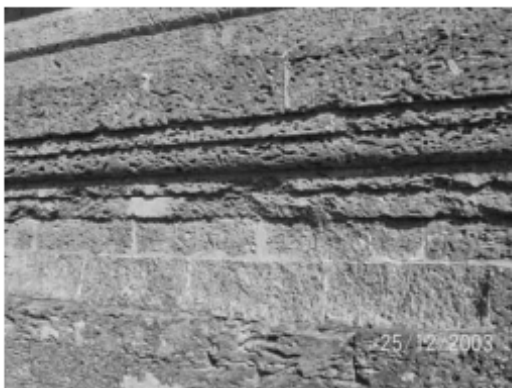
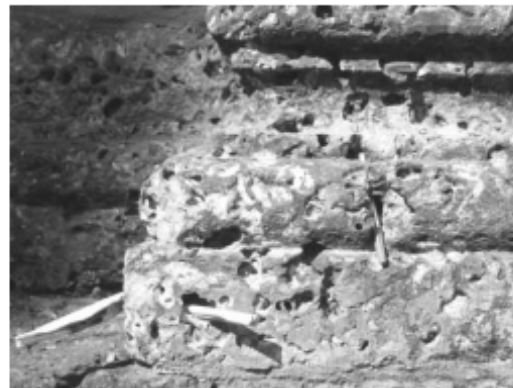
(a) Granular disintegration

(b) Honey combing due to action of rain

Figure 40: Image showing damage pattern in laterite stone (credit: www.hms.civil.uminho.pt)

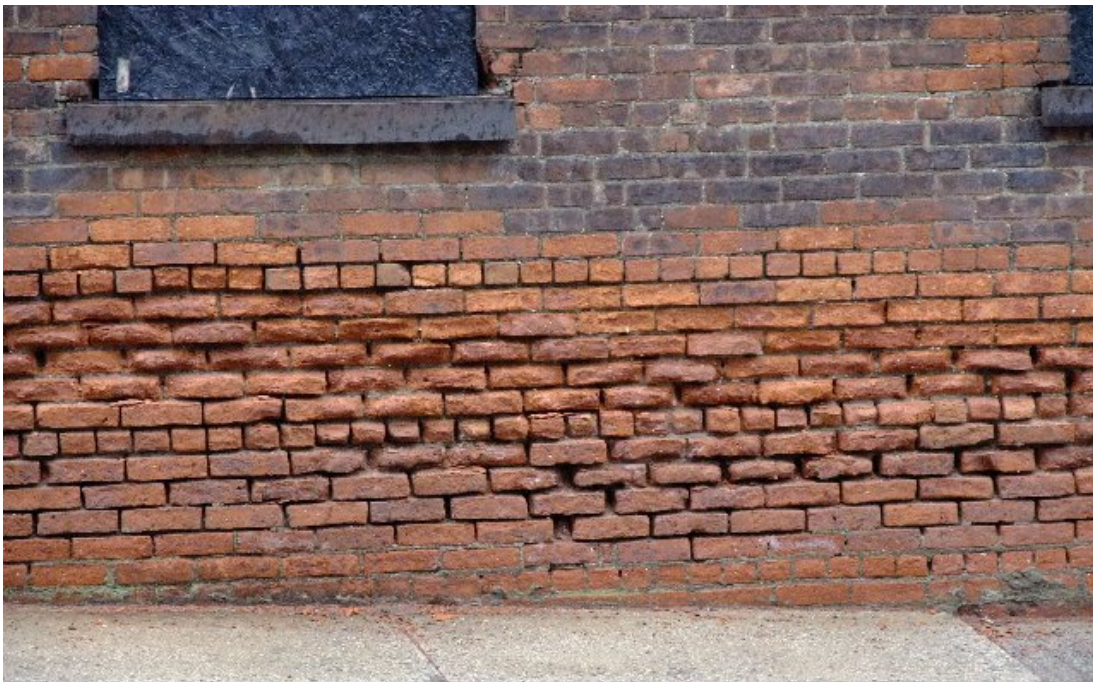
Figure 42: Image showing erosion of mortar due to flood water (credit: inspectapedia.com)

Most of the rural and urban areas in Kerala, Traditional building practice is to build with exposed brickwork, if a building with exposed brickwork experience flooding and intensity of flood water is moderate, in that case it is observed that mortar load bearing walls get deteriorated due to flood water, which lead to decline structural strength. It is recommended to carried out proper risk assessment of all the buildings with exposed brickwork with respect to flood hazard. If the area had experienced flood in past then and the building must be retrofitted by introducing plinth protection using non eroded material around the external wall. Some of the common materials are suggested like wire mesh with RCC, FRP, stone cladding for tile cladding etc.

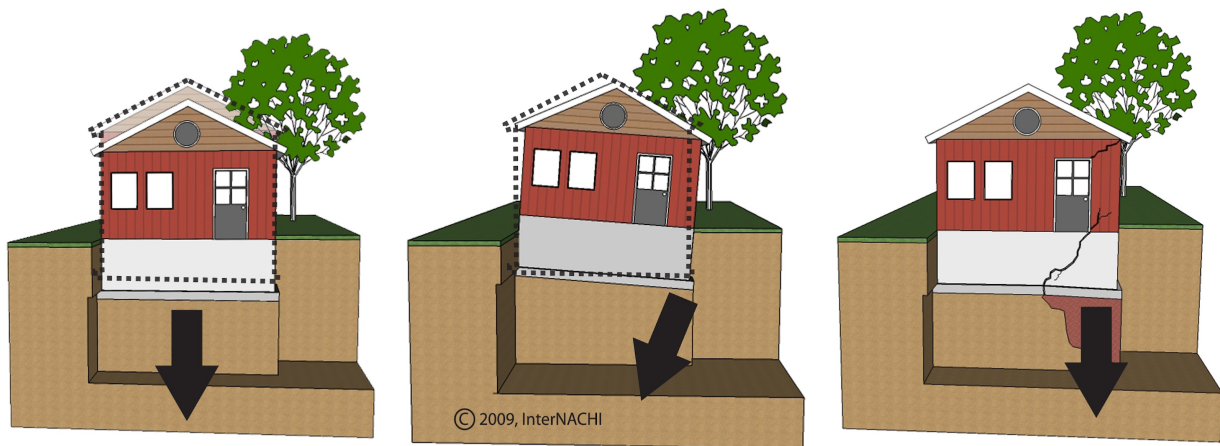
Figure 43: Image showing ground settlement pattern due to flood (credit:www.nachi.org)

1. **Uniform settlements:** In this type of settlement generally no cracks are observed but the whole structure is slinked in the ground.
2. **Tipping Settlement:** In this type of settlement the building is settled from one side and lifted from another site. In some cases, the structure is properly designed and structurally integrated then there is no cracks is observed. This type of settlement in future can cause building instability and damages.
3. **Differential settlement:** In this type of settlement, due to rainwater or non-compact ground soil will settle in non-uniform way. The settlement will cause structural cracks near plinth area on the walls. this type of settlement can cause building collapse.

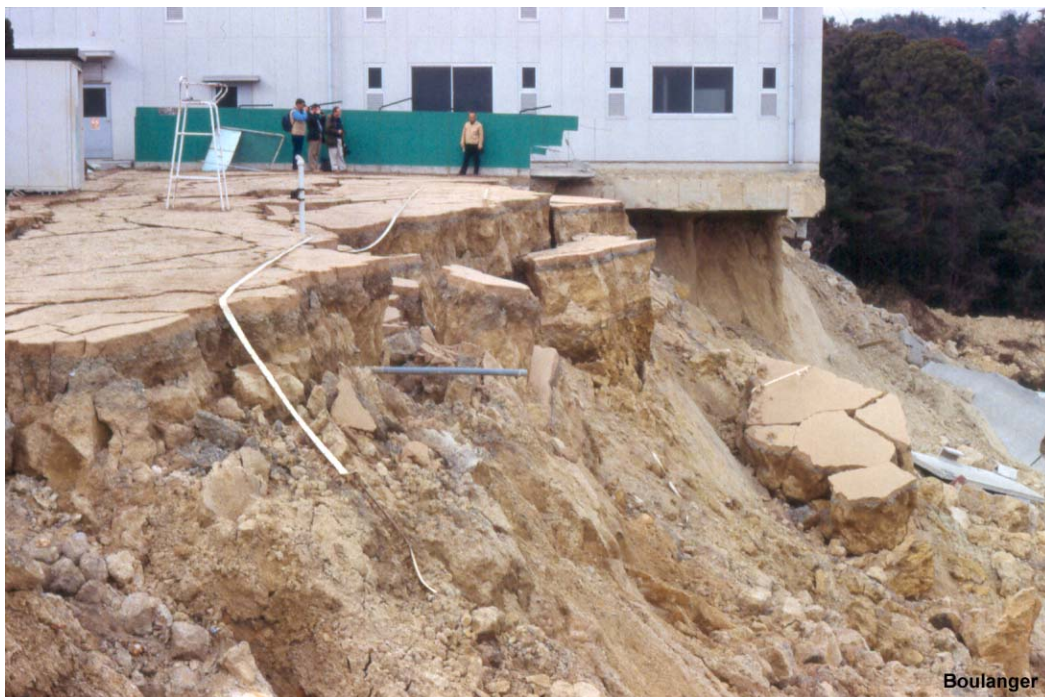
Figure 46: Base soil under foundation eroded due to landslide (credit: <http://www.stuff.co.nz>)

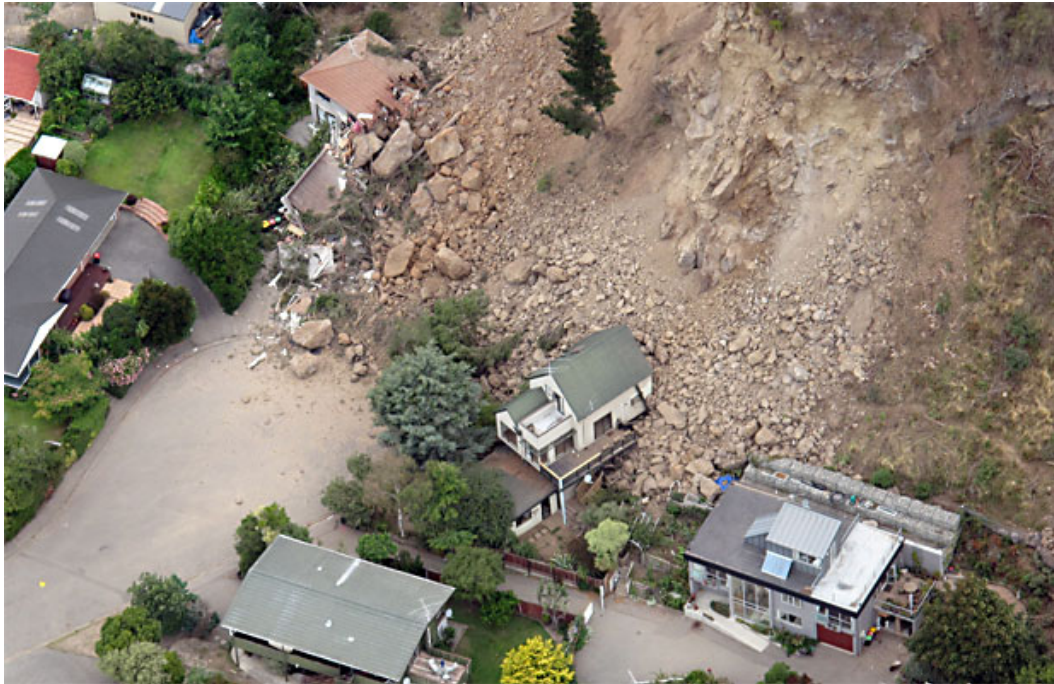
Figure 47: Building partially buried due to landslide (credit: <http://www.stuff.co.nz>)

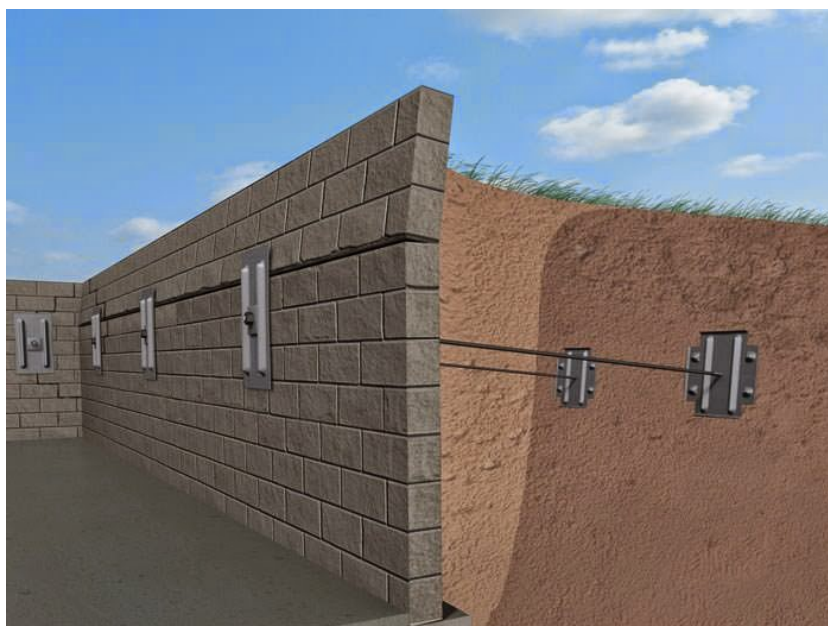
Figure 48: retrofitting using steel plates for basements (credit: TESRA ppt)

1. Anchoring of retaining wall using steel rods and plates.
2. Retrofitting of cracks using FRP.
3. Retrofitting of cracks using Wire mesh.
4. Extension and support foundation using jacks and RCC.
5. Increase the thickness of retailing wall.

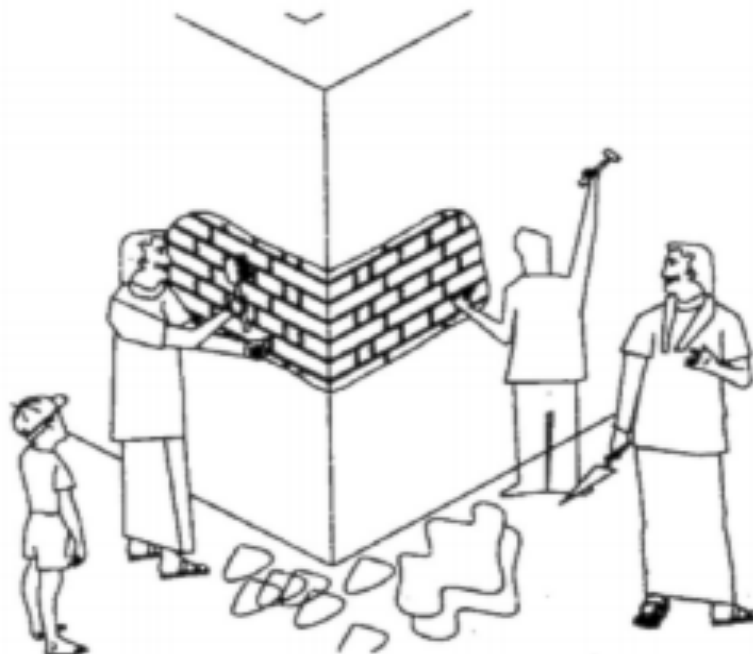
Figure 49: Removal of plaster and raking of joints process (Credit: www.btp.com)
